## **Reconstruction of Special Types of Constructions**

# **APPRAISAL OF THE TECHNICAL CONDITION OF THE STEEL STRUCTURES OF CLINKER SILOS PC1 AND PC2**

## **RECONSTRUCTION OF THE ROOF OF THE ICE STADIUM IN ZVOLEN**

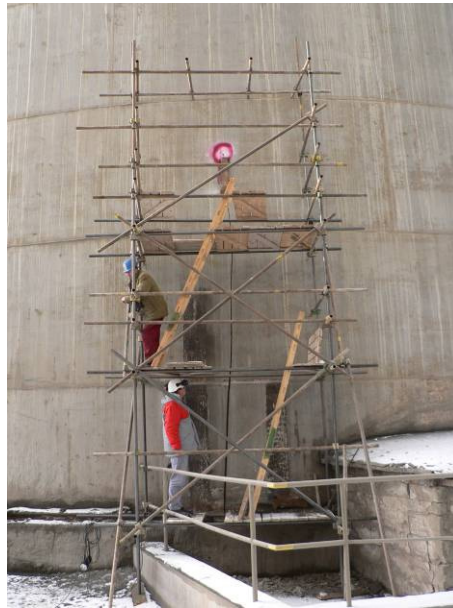
During operation (more than 30 years) two vertical cracks with a length of ~ 6,0m developed in the bottom part of each silo. Views of the repair of the last crack in the clinker silo PC1 are on Figures 2 and 3.

**Fig. 2 View of the Crack in Silo PC2 (November 2005)**

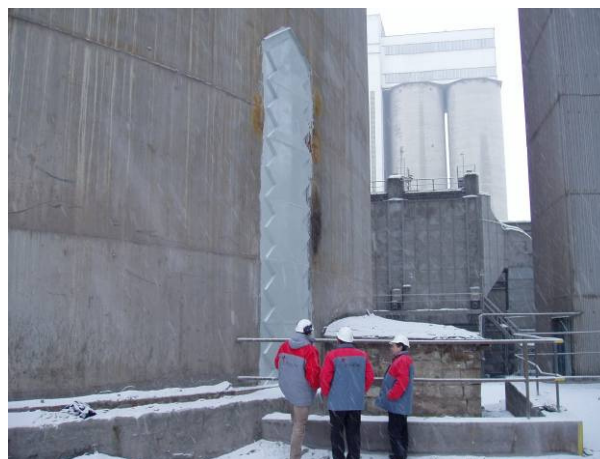
**Fig. 3 View of the Finished Repair at the Damaged Location of Clinker Silo PC2**

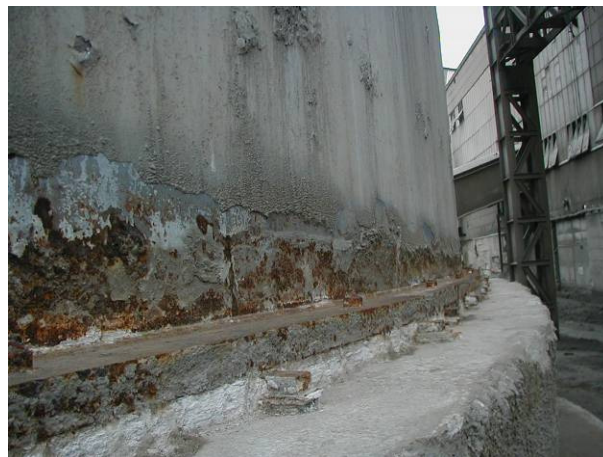
The largest corrosion losses were at the connection of the bottom plate strip of the shell with the base plate (Figure 4). After cleansing a value  $t \doteq 30,1\text{mm}$  near the weld was measured at probe S3. Measurements of the roof plate were also carried out. The mean value of the 3 probes is  $t \doteq 6,2\text{mm}$ .

**Fig. 4 State of the Shell in Contact with the Base Plate**

- the measured, real plate thicknesses mainly in the bottom part of the silo are smaller than the projected ones. During operation a wear of mainly the internal side of the shell occurred and the original thickness is decreased also by corrosion losses. The largest corrosion losses were determined at the connection of the bottom shell plates to the base plate; the real thickness was  $t_p = 30,1\text{mm}$  against the original one 33mm. The loss is up to 3mm.

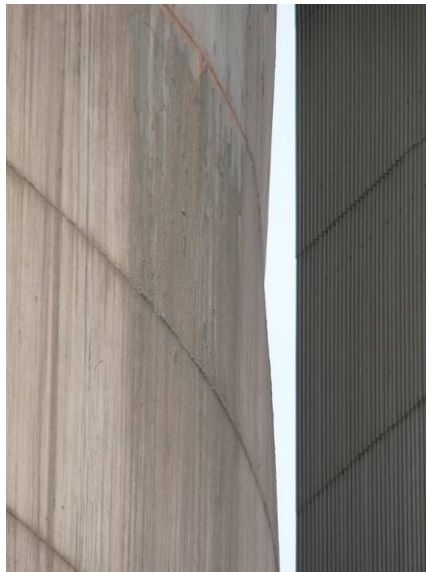
- height differences of the bottom steel ring are at silo PC1 -4,0 to 50,0mm; the upper edge of the foundation strip is not horizontal. The ring of silo PC2 was not accessible for control.
- deviations from the theoretical shell diameter  $r = 18,0\text{m}$  had been found out in various heights. At silo PC1 the maximal deviations are in profile B -57mm (into the silo's interior) and +94mm (out of the silo). In profile F the silo shell is deformed into the silo's interior -76 to -29mm. At silo PC2 the largest deformations are in profile I -50 and +105mm. Because of the magnitude of deformations, it is necessary to make once

**Fig. 5 Local Deformation of Silo PC1 Shell**

in a year a control of the geometric shape of the silos (on the set marks) and in the case of an increase of deformations to take adequate action to ensure silo operation.

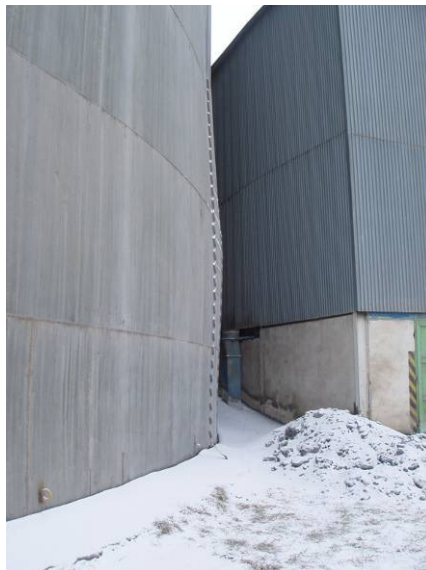
**Fig. 6 Local Deformation at the Damaged Location of Silo PC2**

On the basis of diagnostic inspections, survey of the real silo shape, geotechnical assessment of the foundation and control static calculation a strengthening by means of horizontal rings and vertical stiffeners to a height 15,13m above the horizontal foundation ring was proposed. The total steel S355 need for strengthening one silo was 183,0 t.

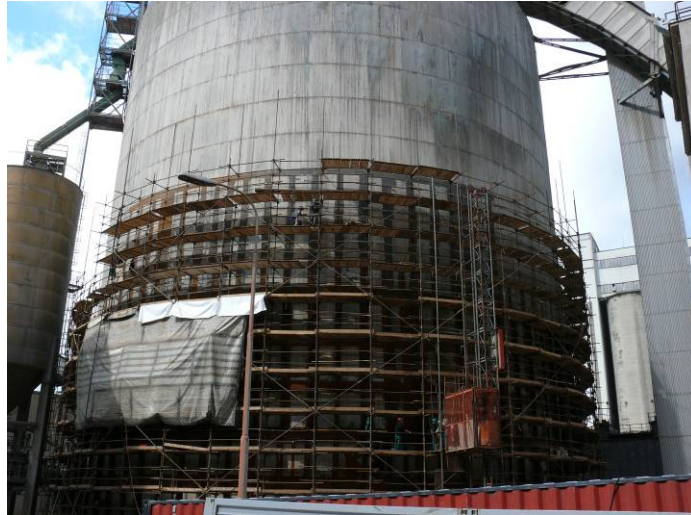
**Fig. 8 Reconstruction Works on the Clinker Silo**

The steel silo shells will be strengthened by a system of vertical stiffeners and horizontal rings. After strengthening the cylindrical shell will act as an orthotropic (orthogonal anisotropic) shell.

The vertical stiffeners are from flat steel with variable dimensions. They will be located around the outer silo perimeter (totally 80pcs) in spacings  $\sim 1514$ mm. Their minimal distance from the original vertical welds is 150 to 200mm.

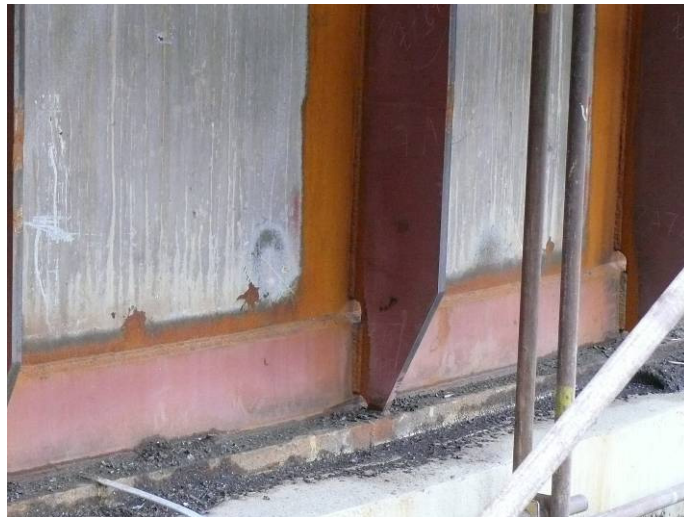
**Fig. 9 Detail of the Strengthening in the Anchorage Area**

The secondary rings are from flat steel 250.25 – 113154. The bottom ring is located over the foundation ring, the other 4 secondary rings are always minimally 200mm above the existing horizontal weld. This rule is valid also for the location of the primary horizontal rings.

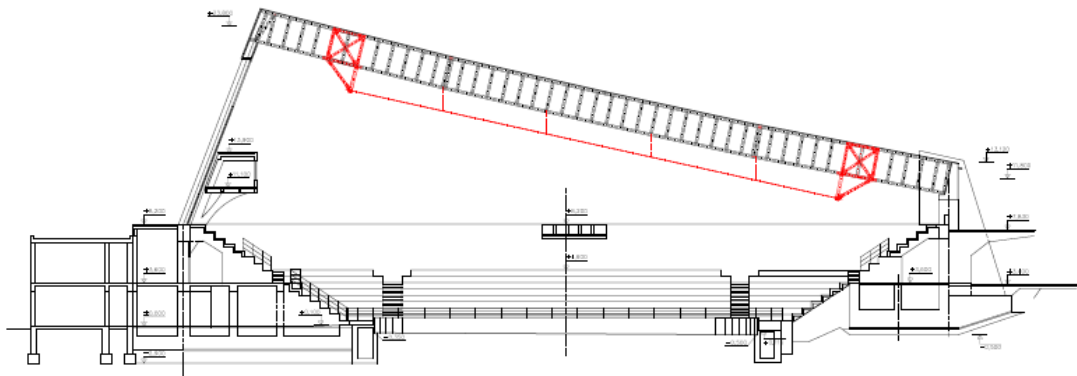
The ice stadium in Zvolen drew attention in the beginning of 2006, when the safe service of the building was threatened. The roof structure reached a 550mm deflection in the middle of the span. The original roof structure, made of glued timber girders was not satisfactory for the ultimate and serviceability limit states. The proposed reconstruction strengthens the original girders by means of prestressing.

The main cause of the extensive deformations (the measured value in 2006 was 463.5mm) was an insufficient resistance of bolted connections.

**Fig. 10 Strengthening of the Timber Girders by Prestressing**

Every original timber glued girder with a total height 2.6m (totally 34 pieces) was strengthened by means of prestressing according to Figure 10. The assembly of the new steel members of anchor brackets and tie rods was performed from the inside of the building (Figure 11).

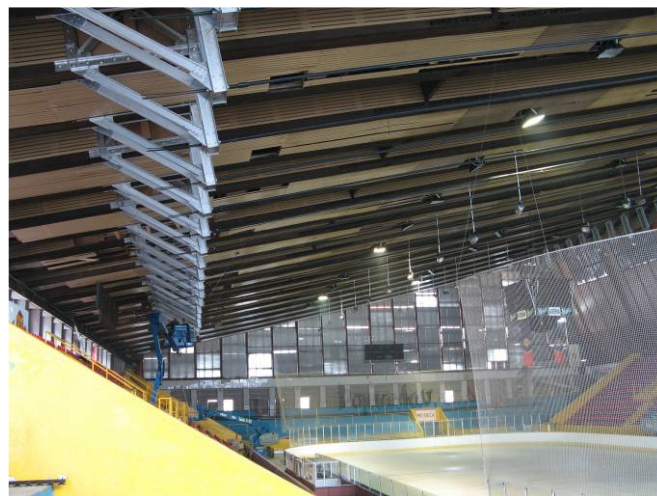
**Fig. 11 View of the Reconstructed Roof Structure**

The steel truss anchor brackets were manufactured of steel S355. The anchorage trusses were supplied to the site as individual members from rolled U-sections of light weight. The members of the anchor brackets have been connected to the timber girders by means of steel bolts with diameter 24 and 32mm. The field joints of steel members were bolted to gusset plates with M16/10.9 bolts.

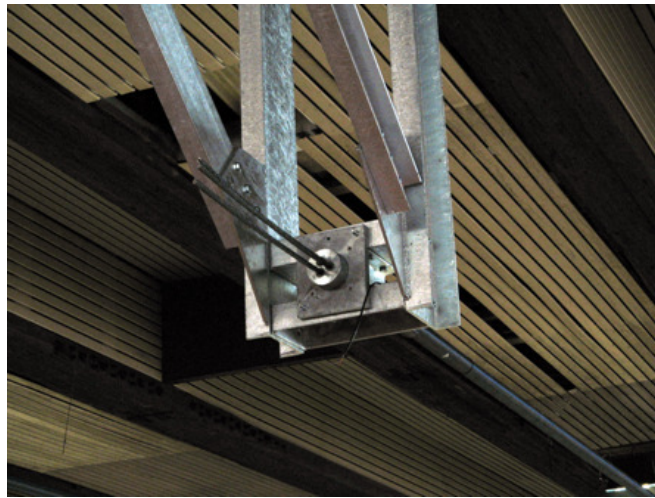
**Fig. 12 Anchorage of the Cable Tie Rod to the Steel Brackets**

The prestress to a maximal axial force in the tie rod  $S_{vRd}=184\text{kN}$  has been applied gradually in four stages. The assumed loading during prestressing was dead load of the girders and the load of the roof cladding. Stressing was performed at the bottom anchor bracket (Figure 12). The prestressing forces are in Table 1.

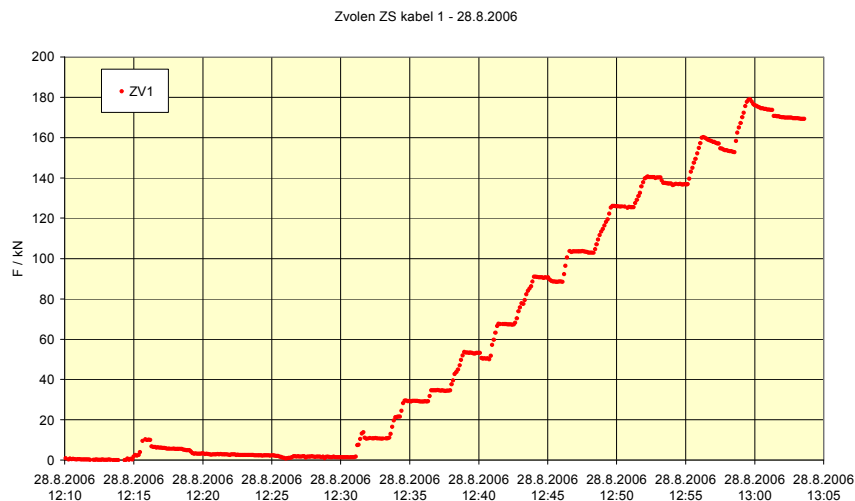
The forces during prestressing have to be measured on each prestressing cable. The strain gauges have been glued directly to the prestressing cables. The prestressing force diagram is on Figure 13. We can see how the prestressing force disappears in the structure. The cause can be the deformation and creep of the girder. Therefore it was necessary to additionally prestress the cables to the prescribed force.

**Fig. 13 Forces in the cable during prestressing**
