THERMAL REMEDIATION OF ROOF STRUCTURE OF THE ST. MARTIN'S CATHEDRAL

SANDANUS, J. & SLIVANSKÝ, M.

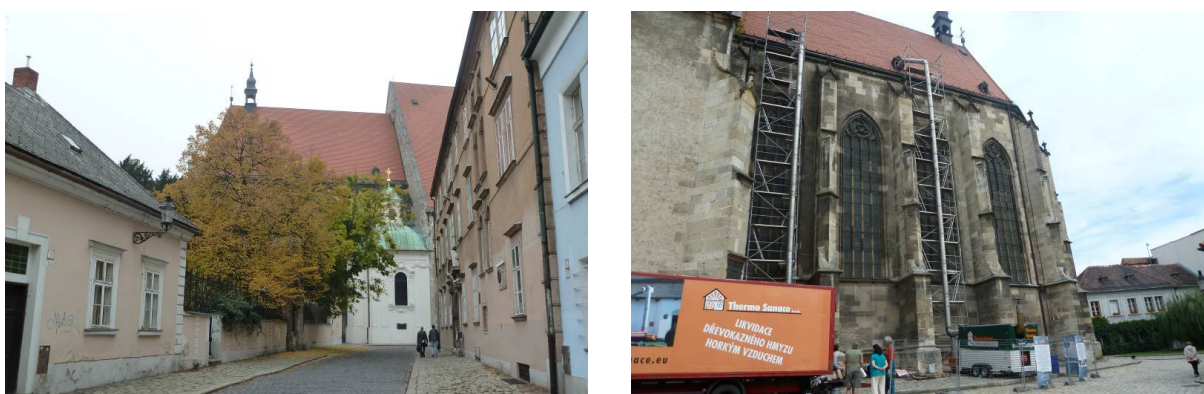
Fig. 1 The roof structure and the installation of the fumigator with the hot-air pipeline

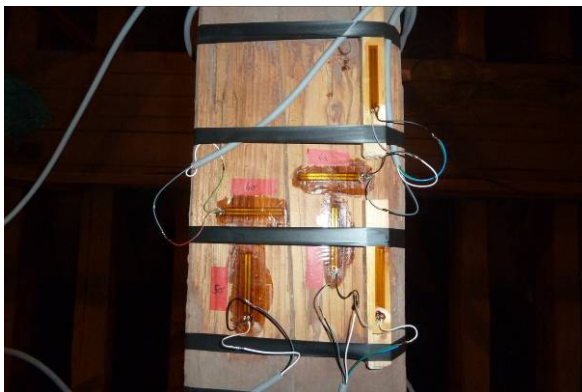
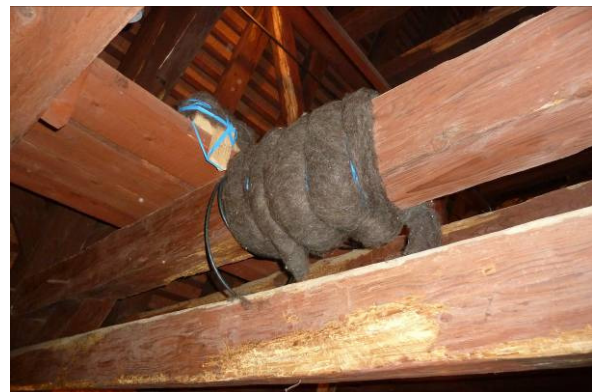
Fig. 4 The strain gauges installation and thermal isolation

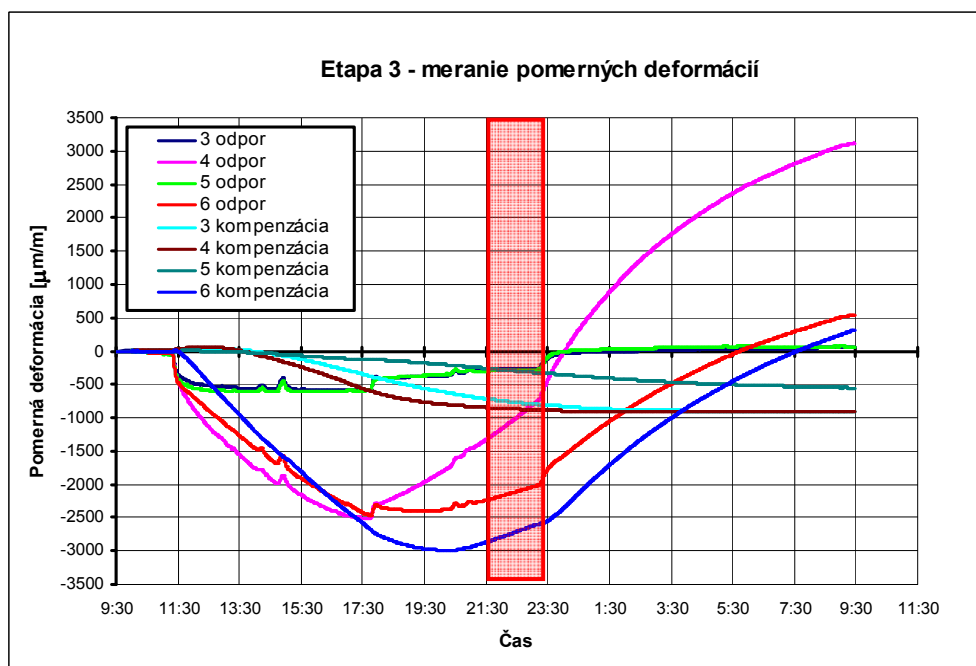
Fig. 6 A course of the relative deformations measurement in Stage 3

According to obtained results of the strain measurement (relative deformation), it can be said, that the volumetric change of the wood material at surface of the timber element due to the change of the humidity (shrinkage, swelling) is more significant than the change caused by thermal expansion of the material. We can not exactly formulate the relationship between the humidity and relative deformations from the experiment, because the humidity of the timber elements was not measured. Generally, the test results proved the theoretical physical properties of the wood as a structural material - the coefficient of the expansion caused by change of the humidity is theoretically 104 times higher than the coefficient of the thermal expansion.

The change in the volume of the wood material in perpendicular direction to wood fibres was also more significant comparing to the direction parallel to wood fibres. The experimentally obtained data of the relative deformations in perpendicular direction (4 resistor, 6 resistor, 6 compensation) were several times higher than the relative deformations in parallel direction. This trend corresponds also with the theoretical values, which is the ratio between different directions $\alpha_{Tan}: \alpha_{Rad}: \alpha_{Lin} = 15:10:1$ generally given (approximately the identical ratio is used both to the change in volume due to humidity and thermal expansion).

The more significant volumetric changes appeared probably on the surface of the timber members, because these results of strain's measurement followed the increase and decrease of the temperature during the heating of the roof structure very strictly (increasing of the temperature = increasing of the relative deformations and vice versa), and after interruption of the heating they gradually disappeared. It is very important to notice, that the results of the strain gauges without compensation (the measurement points named "resistor") are strongly affected by the influence of the temperature on the electronic equipments (tensiometers, resistors, wires, etc.), so the trends of the results are mainly interesting, not the numerical values. Despite the fact, the error of the measurement using the strain gauges with compensation is reduced, it can not be completely ignored, because the wood is very inhomogeneous material (direction of the wood fibres, cracks, etc.).

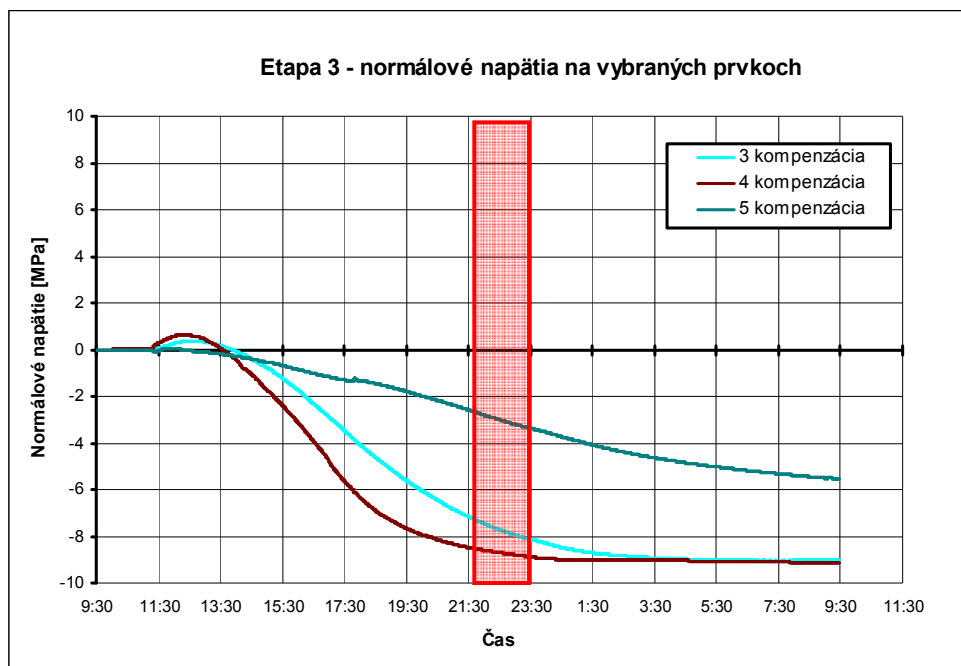
The normal stress was evaluated only in the measurement points with compensated and in the parallel direction oriented strain gauges. Due to the thermal longitudinal expansion of the wood, the increasing of the temperature produces the compressive stresses in the measured structural elements. Increasing and decreasing of the normal stresses did not follow the ambient temperature simultaneously, but a specific time delay was obvious. Even the heating of the roof structure was finished, the normal stress faded out in the time gradually (figs 7 and 8). As a result of the long-term strain gauge measurements it can be considered, that the normal stress finally reduced to the same level as before the thermal remediation in the next couple of days (fig. 8).

Fig. 7 A course of the normal stresses measurement in Stage 3

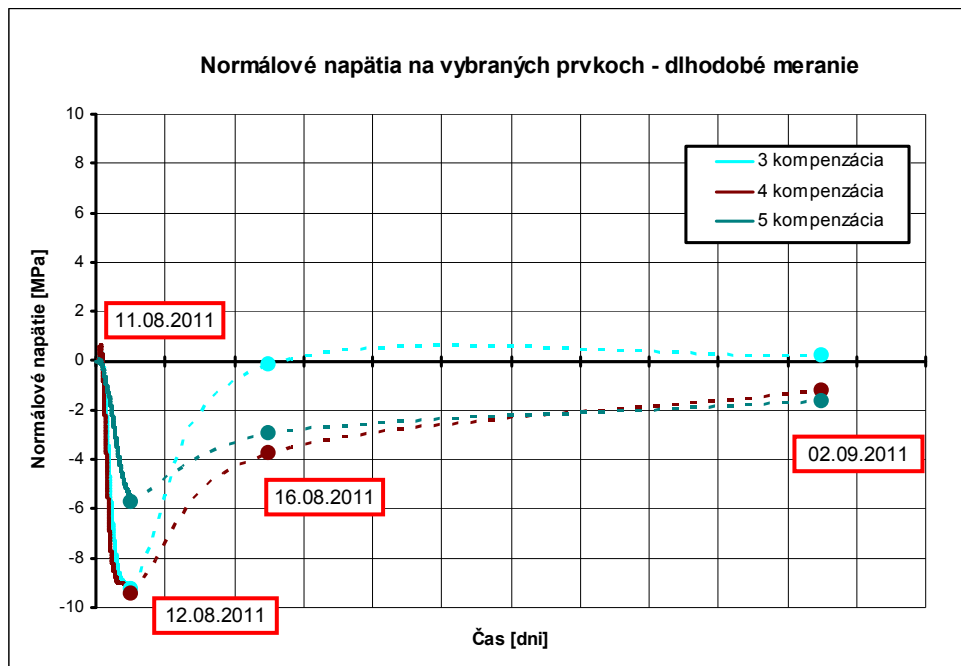
Fig. 8 A course of the normal stresses measurement, long-term results
