# EXPERIMENTAL VERIFICATION OF THE RESISTANCE OF GLASS BEAMS

**Miloš SLIVANSKÝ**

Department of Steel and Timber Structures,  
Faculty of Civil Engineering,  
Slovak University of Technology,  
Radlinského 11, 813 68 Bratislava

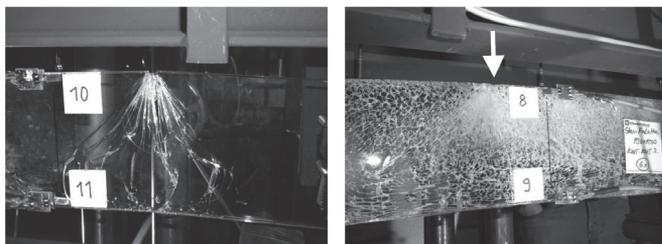
**Fig. 3.1** Typical breaking behavior of ANG (left) and FTG specimens (right).

The brittle breaking behavior of the glass elements for both types of beams (ANG and FTG) occurred through their total collapse, which had not been preceded by any noticeable formation of cracks,

so the beams suddenly failed. For the beams made of float glass the final damage was strictly of a local character (one crack and intact compact parts); the beams made of fully tempered glass were broken into many small pieces due to the heat treatment, and some of the fragments were ejected for quite a distance. The broken specimens showed no residual resistance, despite the fact that the broken parts were connected by PVB foil.

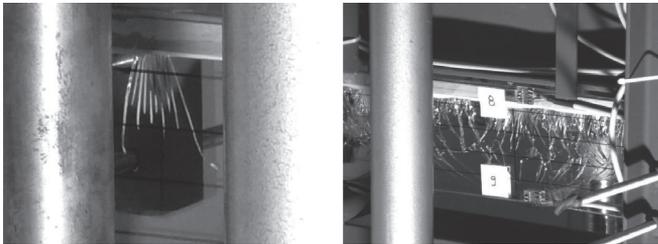
**Fig. 3.3** The initial cracks and their growth before the final collapse of the specimen.

All of the reinforced beams made of float glass were able to carry the increasing load, and none of them collapsed after the first crack had occurred. The initial crack was formed on the tension edge of the beams. The cracks had a slightly branched shape and were oriented perpendicularly to the edge of the beam. They formed in both layers of the laminated glass almost simultaneously; in most cases they were in the area of the maximum bending moment. The initial crack's length was limited to a maximum  $3/5s$  of the total height of the beam's cross-section. New cracks were formed under the increasing load, and the existing initial cracks grew.
