## **Reconstruction of Special Types of Constructions**

# **APPRAISAL OF THE TECHNICAL CONDITION OF THE STEEL STRUCTURES OF CLINKER SILOS PC1 AND PC2**

## **RECONSTRUCTION OF THE ROOF OF THE ICE STADIUM IN ZVOLEN**

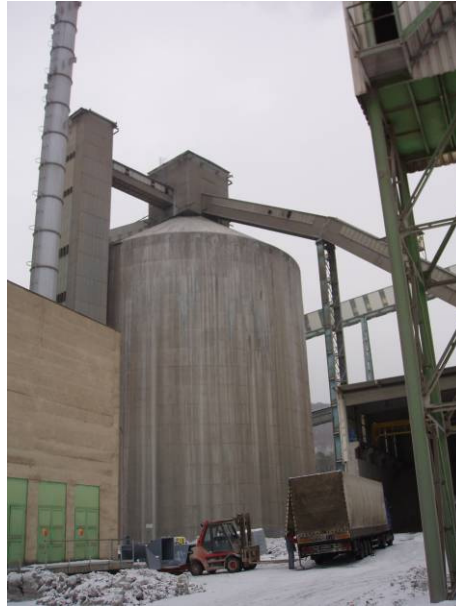
**Fig. View of Clinker Silo PC2 with Technology**

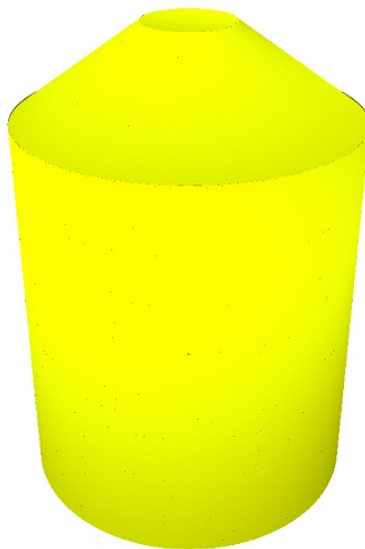
The aim of the calculation was to verify the existing clinker silo structures, to determine possible causes of failures and to propose necessary adaptations of the clinker silo structures. The load-carrying silo structures were checked according to the ultimate and serviceability limit states.

**Fig. 7 Structural Model of the Silo**
