THERMAL REMEDIATION OF ROOF STRUCTURE OF THE ST. MARTIN'S CATHEDRAL

SANDANUS, J. & SLIVANSKÝ, M.

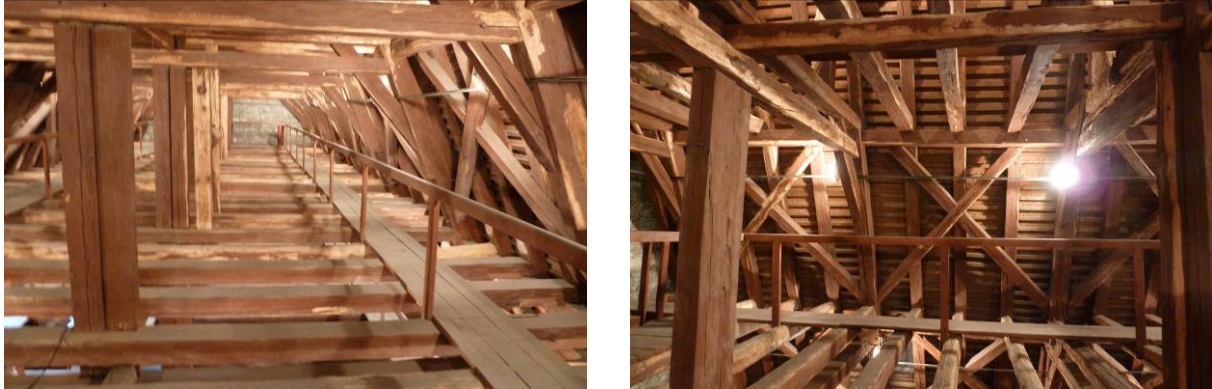
Fig. 2 The structural system of the roof construction

The roof structure of the chancel is 4 story construction. The roof is closed on the front side by hipped end and small tower, on the other side the roof is linked to the main structure of the cathedral. In the longitudinal direction is the roof structure braced with a diagonal bracing system located between the main supporting frames situated in the sloped plane.

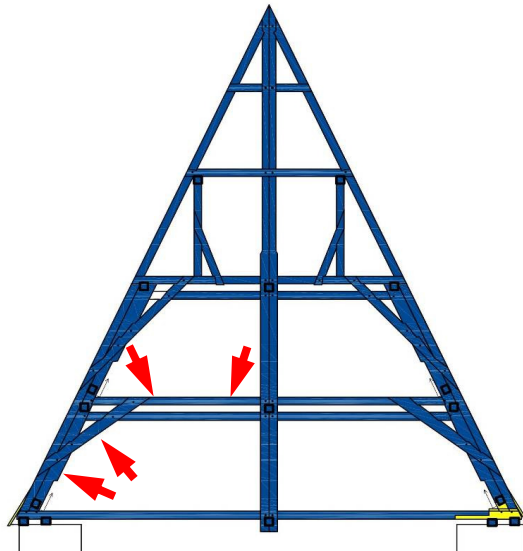
Fig. 3 A schematic view of the structural system of the roof construction and location of the measurement points

The effect of increasing temperature during the thermal remediation was monitored by the strain gauge measurement. The strain gauges were mounted on the surface of the selected structural timber members by 2-component epoxy adhesive. The measurement points were selected with regard to the expected normal stresses (compression or tension) due to the uniform heating of the roof structure and accessibility of the structural member. The strain gauges were situated either on the upper edge of the horizontal 1st floor's spanner (10 measurement points) or on the edge of the diagonal roof brace (2 measurement points). One of the strain gauges was situated separated from the roof's structural members on the independent specimen of the timber. The names and location of the strain gauges measurement points are shown in table 1.

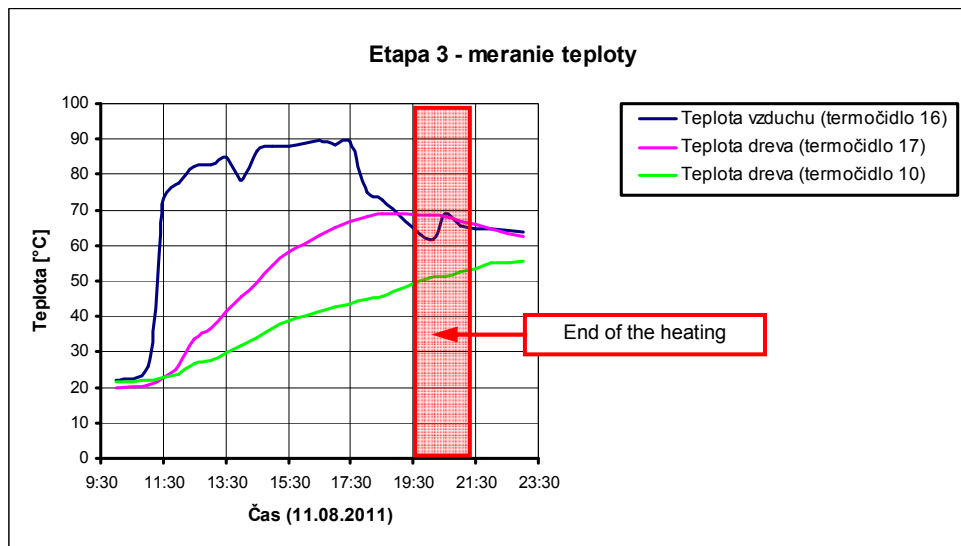
Fig. 5 A course of the temperature measurement in Stage 3

The time-history of the temperature of the roof structure was monitored by employees of the company Thermo Sanace s.r.o. during the thermal remediation for a relatively large number of the measurement points. A course of the temperature measurement for selected points is illustrated in Fig. 5.
